Mosaic and Trencadís in the Palau De La Música Catalana

Abstract

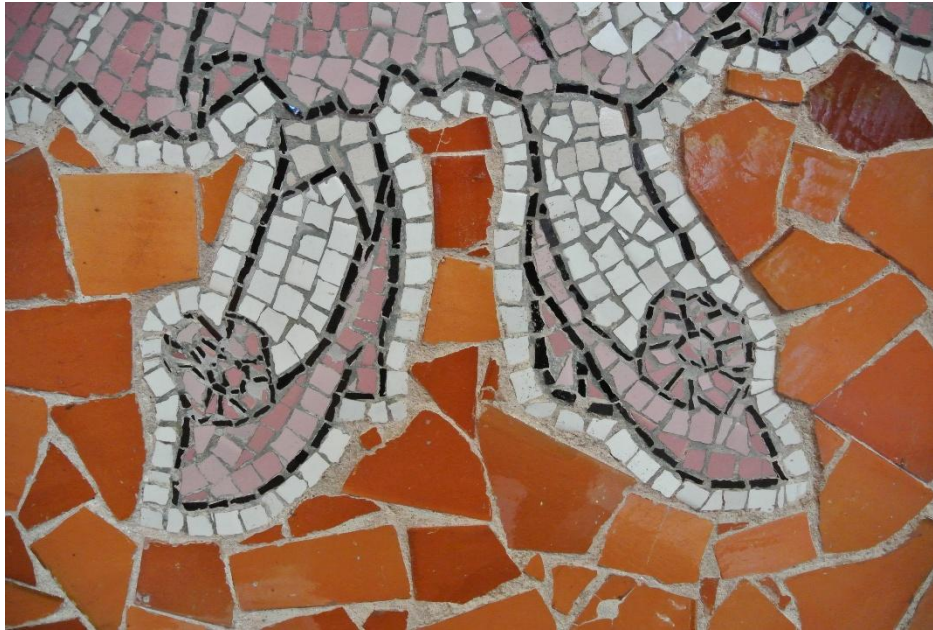
Figure 2. Detail of the trencadís in the background and the mosaic on the feet of a muse.

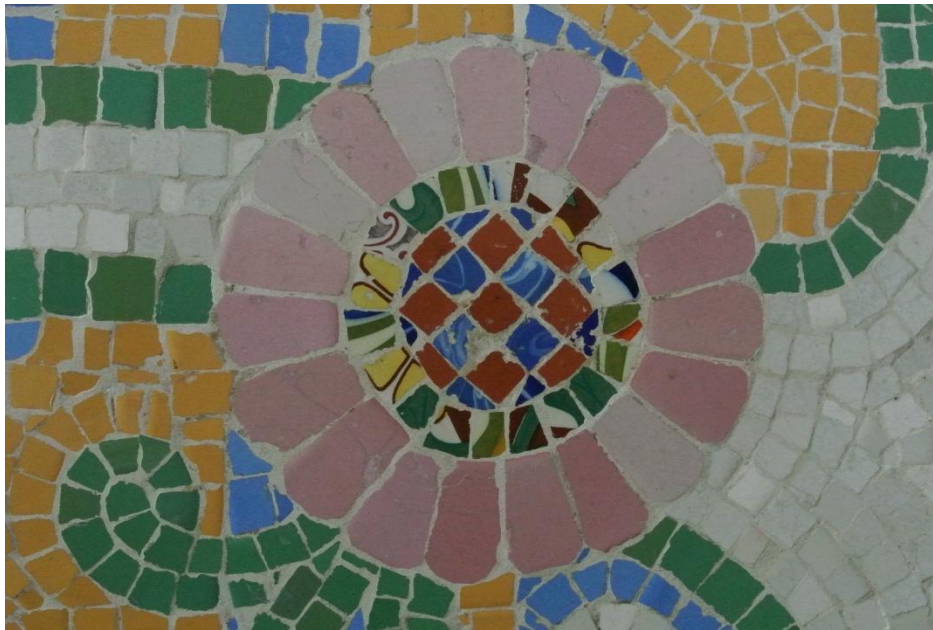
Figure 3. Mosaic with glazed, decorated tesserae in one colour, cut in a square shape and in the shape of a petal.

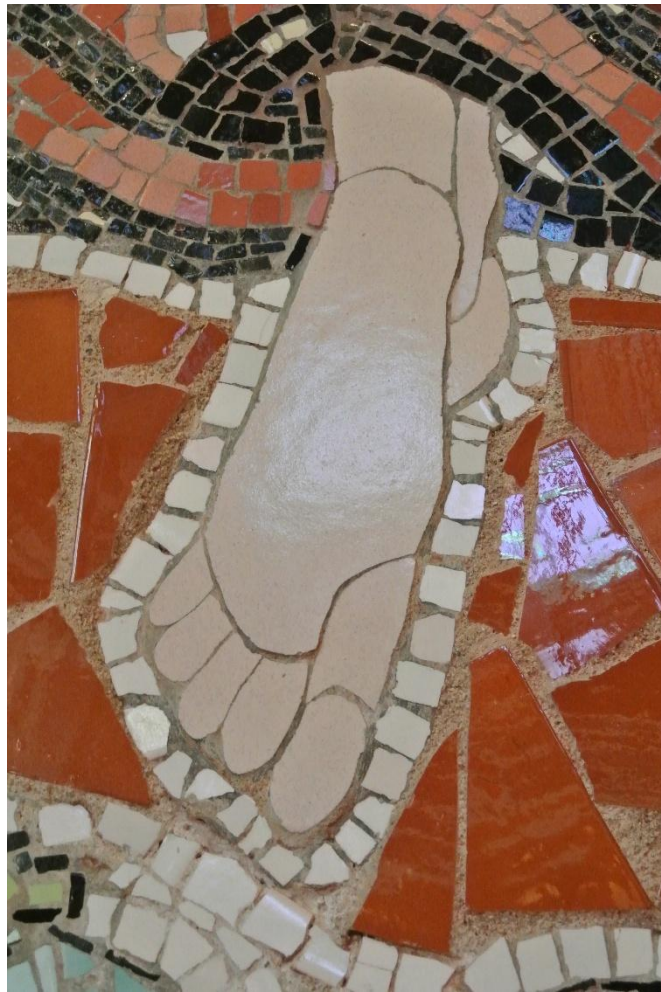
Figure 4. Monochrome ceramic pieces, cut in a desired shape forming a mosaic.

There are also mosaics made with tiles that have intentionally defined shapes that create the desired composition (Figure 4 and 5). Trencadís is a peculiar and distinctive trait of Modernisme in Catalonia. It is a procedure made using irregular pieces of glazed tiles fragmented randomly and replaced in an abstract form. This type of mosaic became very popular during the Modernisme era and became a characteristic and unique feature. One of the examples that we can find in the Palau is the monochrome background of the stage where 18 muses can be found with their decorations.

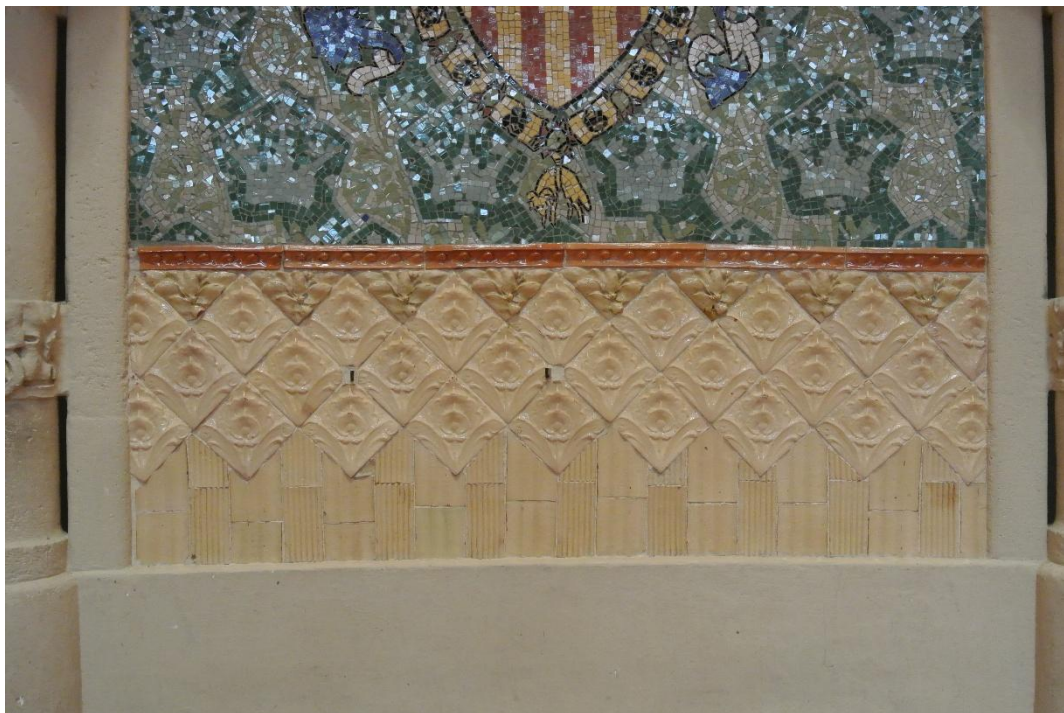
Figure 5. Tesserae mosaic and tiles in one colour, both smooth and with relief.

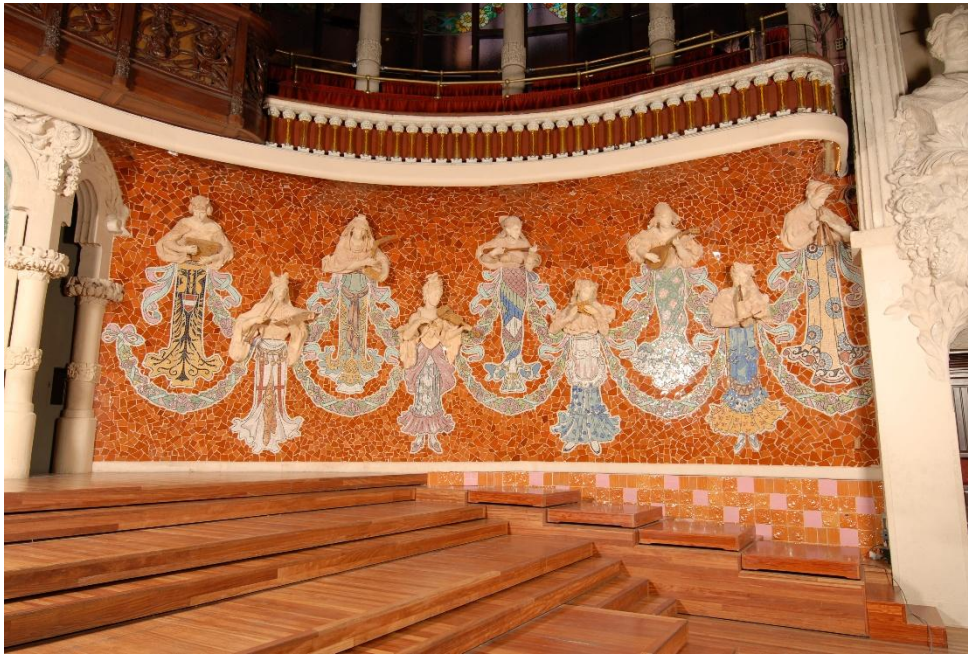
Figure 6. Final state of the right side of the chamber of the concert hall after the restoration intervention (photo by Josep Blanco).

Finally, mortar was used to ensure the stability of the pieces and to close the holes made by the fixings. This process was carried out using lime mortar and a mixture of sand and gravel in different colours to match it to the general tone of the mortar (Figure 6).

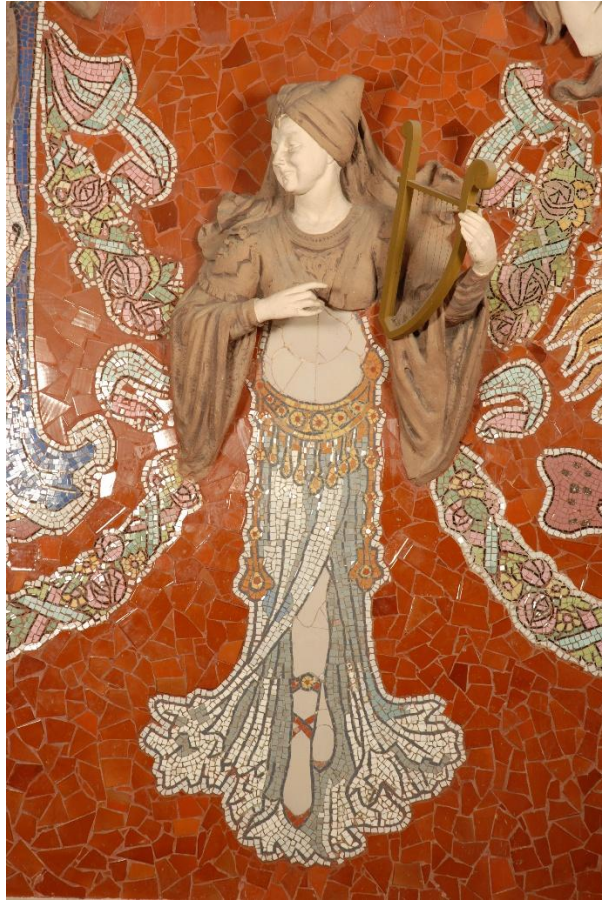
Figure 7. Muse of the lyre before restoration (photo by Josep Blanco).

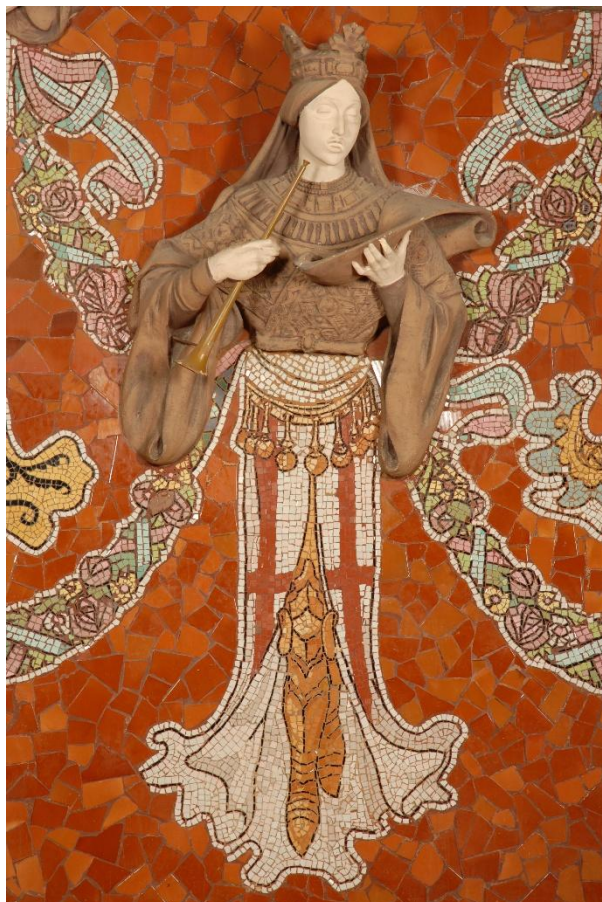
Figure 8. Muse of the voice and trumpet before restoration (photo by Josep Blanco).

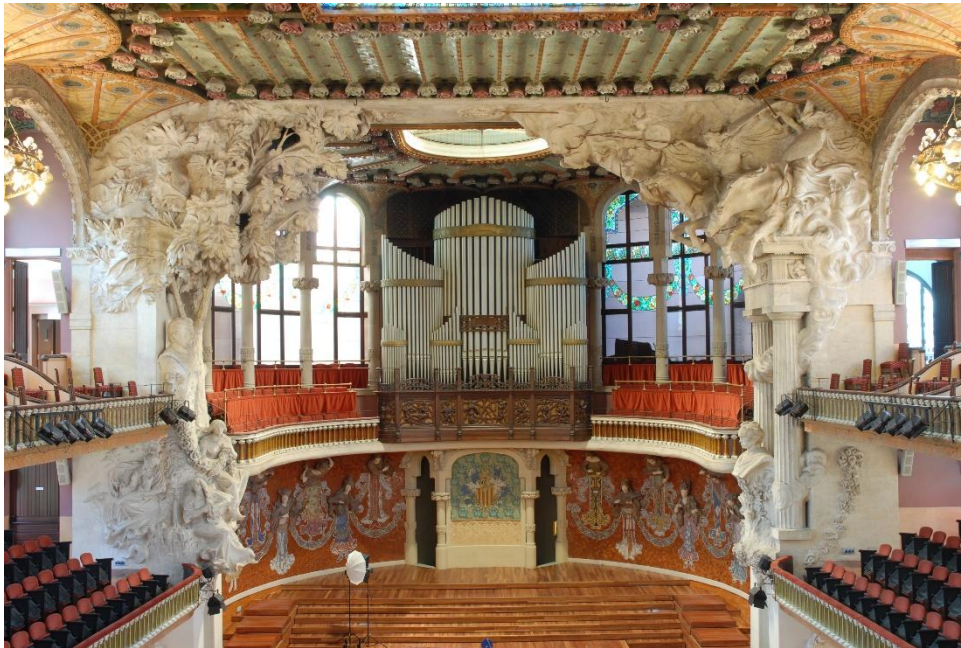
Figure 10. Image of the chamber from 2007 before the restoration intervention (photo by Josep Blanco).

Thus, the coats of paint applied to the stone and the ceramic conditioned the vision of the decorative ensemble due to the loss of volume, texture and colour. The brown tones were carried out on the stone and according to the tonality of the pieces of mosaic a yellow, red or green paint was applied. Regarding the colour of the mortar joint of the "trencadís", it was painted in a red tone similar to the tiles, creating a vision of a flat background. From its opening in 1908, the Palau has been used continuously for concerts and cultural acts. This created another problem, the loss of material on the figures due to knocks during the constant coming and going of people and equipment of a certain height. Also, the amount of adhesive tape used for cables found stuck to the ceramic gave it a dirty aspect. The loss of mortar joint of the ceramic or damage caused by knocks, holes and fixings can also be added to this long list. All of this shows the lack of preservation over the years.

During the fourth intervention in 1995, the last one to be documented, the construction company Natursystem superficially cleaned the stone muses and their instruments. Lastly, in 2007, Policromia carried out the restoration of all the elements on the stage to restore it to its original state under criteria of minimum intervention and maximum respect towards the work (Figure 10).
